The Municipal Pipeline

Bionax[®] Impresses After Encounter With A Directional Drill

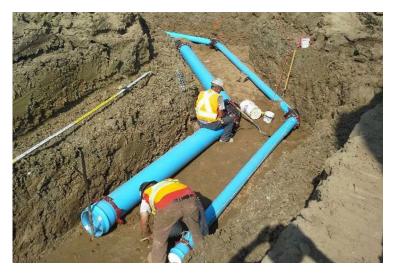
"The job was pretty straight forward. We had a 12" water line to install for fire protection, and a 4" water line to install right next to it for future use. We used IPEX's Bionax PVCO pipe for both lines" said Smith. Unfortunately just 48 hours after PV- Ex's work was completed and the new watermain commissioned, a 4" gas line was being installed and the contractor drilled directly through the center of the new 12" watermain.

"They hit it head on, and as soon as I got the call, I knew exactly what had happened". Smith rushed over to the site and was immediately met with water gushing out of the ground at the adjacent joints, but only bubbling out of the ground where the conflict was.

"I was really surprised that the Bionax PVCO held together. Had this had been a C900 pipe the damage would have been much more extensive with a bigger mess to clean up". Smith's crew worked fast as they cut out a 6 foot section and tied in the repair with two couplings. "The repair was clean, and easy to complete as the damage was contained within inches of the affected area".
