Bionax® Impresses After Encounter With A Directional Drill

Product: Bionax® PVCO Pipe

Contractor: PV-Ex Construction

Municipality: Lakeshore, Ontario

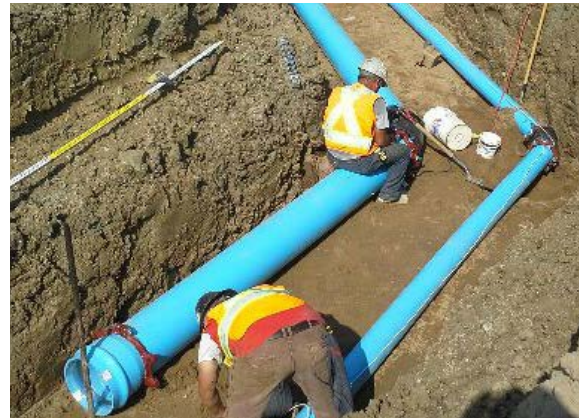
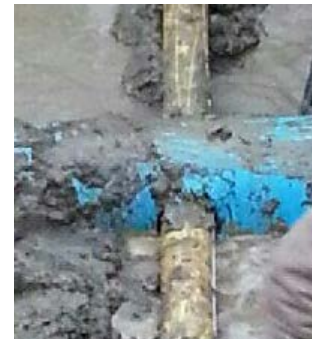
"They hit it head on, and as soon as I got the call, I knew exactly what had happened". Smith rushed over to the site and was immediately met with water gushing out of the ground at the adjacent joints, but only bubbling out of the ground where the conflict was.

"I was really surprised that the Bionax PVCO held together. Had this had been a C900 pipe the damage would have been much more extensive with a bigger mess to clean up". Smith's crew worked fast as they cut out a 6 foot section and tied in the repair with two couplings. "The repair was clean, and easy to complete as the damage was contained within inches of the affected area".

This experience was an example of how Bionax's unique material structure encourages failures to remain local and limits the size of the area to be repaired when such an incident occurs.
